## River Narew – Poland, Flagship restoration measure [1]

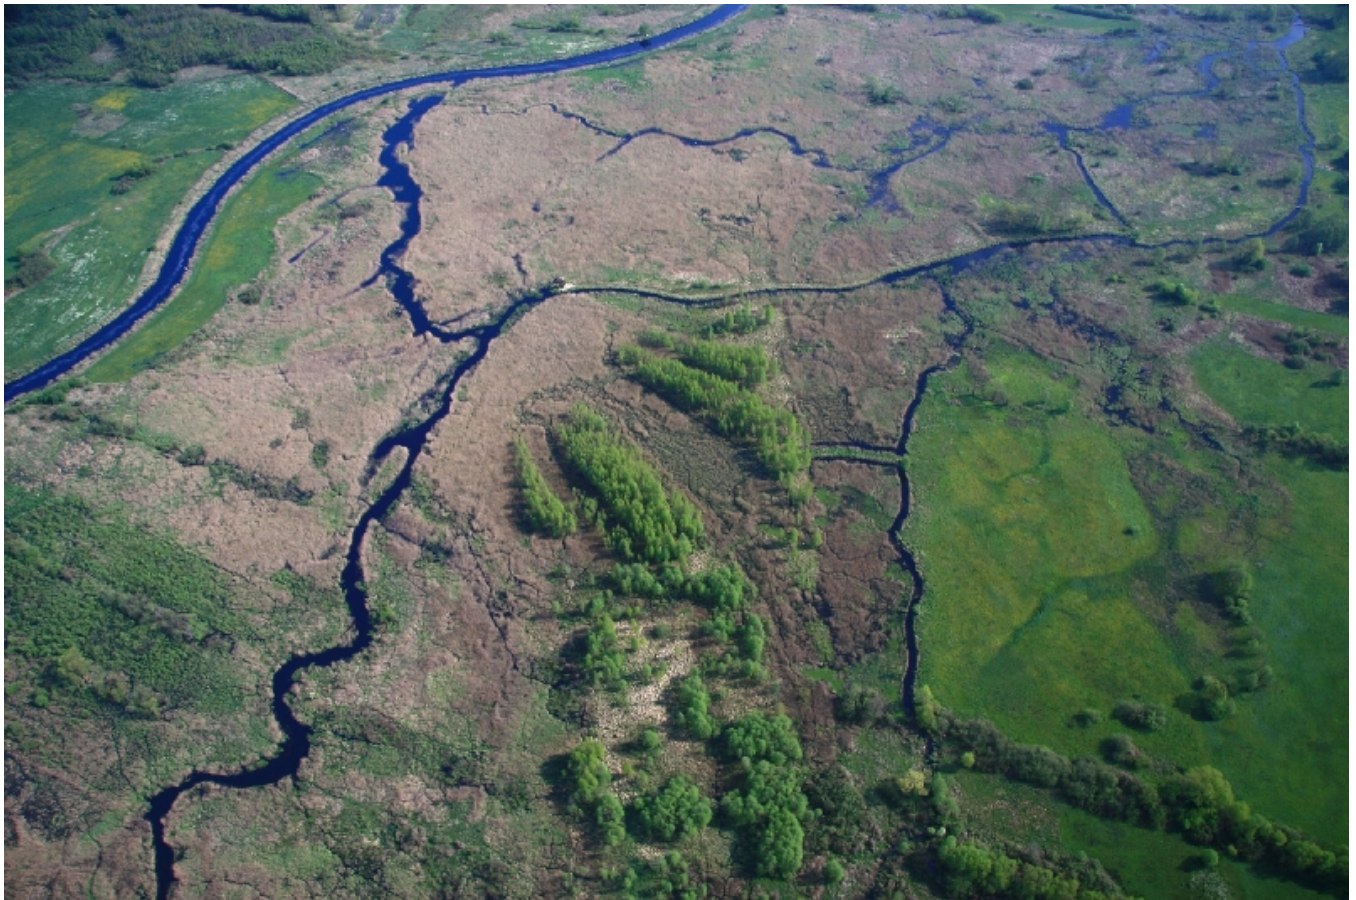
The site is located downstream of the Narew National Park in its buffer zone. The National Park protects the natural anastomosing stretch of the river. In the sixties [2] the river below of the Park was channelized and straightened for the agricultural purposes. This pressure has caused degradation of the anastomosing character by cutting off and therefore shallowing and overgrowing of side channels and losses in biodiversity. Almost twenty years ago it was decided to restore most of the upper part of the degraded stretch, adjacent to the National Park. The main objectives were to bring back a natural value of the river valley and to restore the natural anastomosing river network. The main applied measures were: thresholds to rise water level, divert some of the water into old side arms and slow down the water outflow from the area, and redigging, clearing and re-connecting the old side channels.
