Restoring the channelized River Vääräjoki (Finland) towards good ecological status

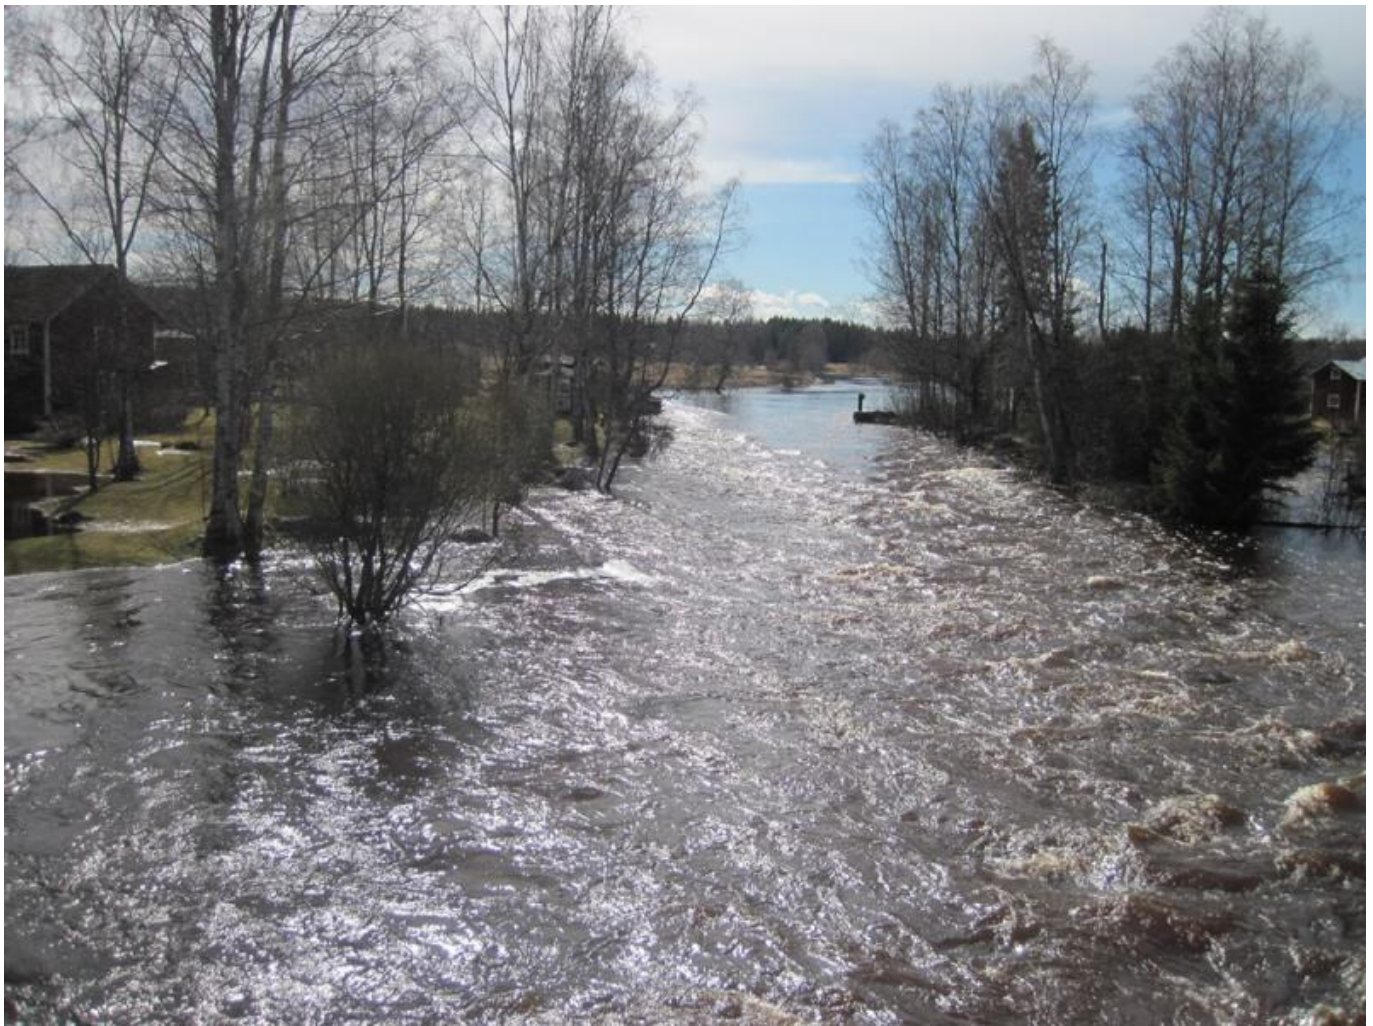
Figure 2. The spring floods at Vääräjoki. Photo: Maarten Plug.

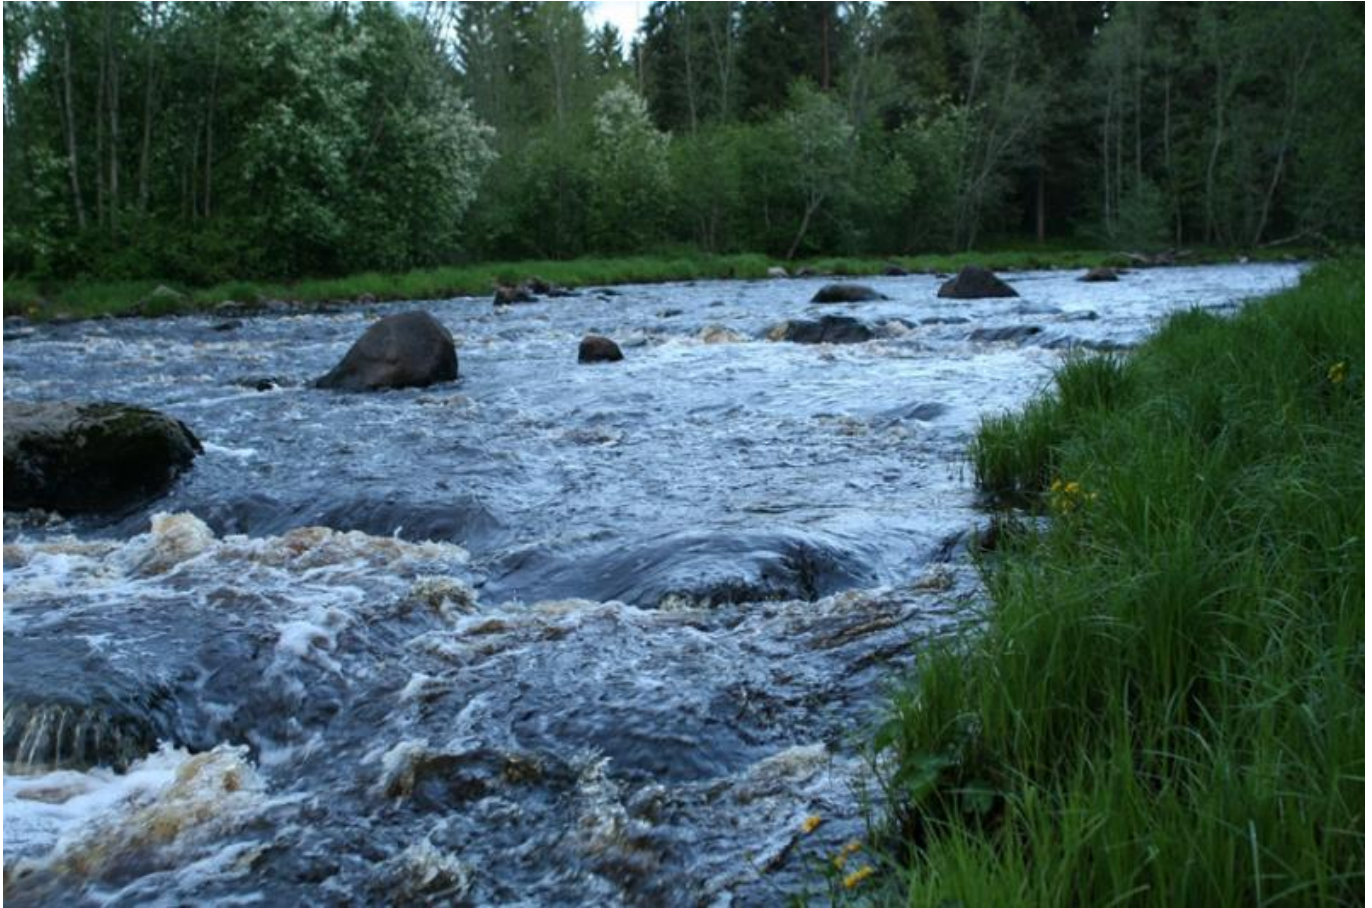
Figure 3. The restored riffle Niskakoski at Vääräjoki. Photo: Jukka Aroviita.

Nowadays, all rapids in the section from 13 km to 29 km upstream of the river mouth have been restored. These extensive works were started in late 1990s and were finished in 2006. The main aim has been to return the heavily modified river closer to its natural hydrological and morphological state and particularly to enable fish migration and spawning. The stream bed was rearranged using boulders that had originally been removed from the channel during channelization and placed along stream margins (Figure 3). Also, gravel beds were created to provide nursery habitat for salmonids.
