REstoring rivers FOR effective catchment Management

Deliverable D3.5 Large Rivers

Title Large river regulation and rehabilitation in Europe – six selected case studies

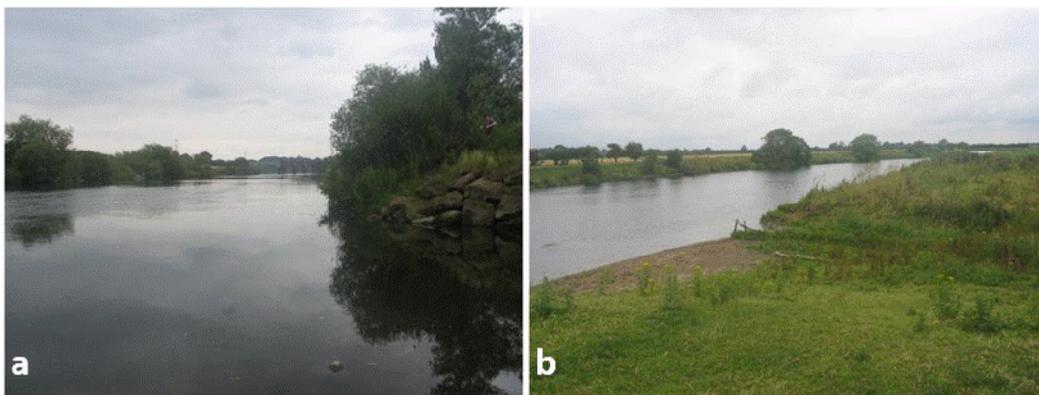
The present channel conditions are homogenous, morphologically uniform and relatively inactive (JBA, 2009, 2010) (Figure 2.4a and 4b). The channel is over-deepened in response to lack of lateral migration, floodplain gravel reworking and inputs of course material for bank protection (JBA, 2009, 2012).

Figure 2.4. The River Trent at (a) Holme Pierrepont and (b) Winthorpe (Photos: Andy Nunn).

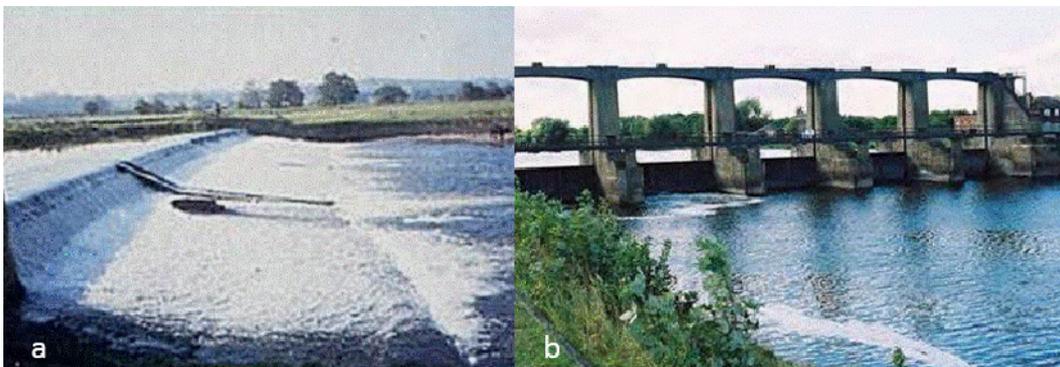
Figure 2.7. a) Cromwell Weir and b) Holme Sluices on the River Trent.

River fragmentation: The industrial heritage of much of the Humber and Trent basins means that there is a large number of potential barriers to fish migration (Cowx & O'Grady, 1995; Nunn et al., 2007a, 2009, 2011, 2012a, b; Nunn & Cowx, 2012). The Trent was an important salmon river prior to the Industrial Revolution, with the majority of production in the Rivers Dove, Derwent and Trent main stem (Cowx & O'Grady, 1995). Numerous weirs (Figures 2.5 & 2.7a) and tidal sluices (Figure 2.7b) are present in the Trent catchment, >2194 weirs are listed in the Environment Agencies National Obstruction's Database, most of which cause obstruction to the natural continuum of the river (Sykes, 2004). These obstructions consequently affect hydromorphological processes, such as water flow and sediment movement, further influencing hydromorphological variables, such as flow magnitude, channel width, water depth, riparian recruitment, siltation and substratum size. The weirs on the Trent should be passable by most fishes at moderate or high flows, but potentially impede upstream movements during low flows (Sykes, 2004). In addition, the tidal barriers prevent natural mixing between fresh and saline waters, which can have consequences for ecological communities (Environment Agency, 2009b) and prevent free movement of migratory species, such as eel (Nunn et al., 2009, 2011, 2012b; Nunn & Cowx, 2012). Many of the weirs on the Trent were built in the industrial past and are protected under heritage legislation, so cannot be easily modified. Some weirs have been modified for small-scale hydropower development and can cause conflict with improving ecological status, but equally they can provide an opportunity to build fish-passage facilities to improve connectivity. An example on the Trent is the low-head hydropower scheme at Beeston Weir, which became operational in 2000, where environmental enhancement was incorporated into the design (AMEC, 2012). This included reducing the size of the scheme and the volume of excavated material to be removed, introducing a fish screen/bubble curtain, improving passage for both salmonid and non-salmonid fishes, and including a tail-race design to recreate a suitable hydraulic regime for gravel-shoal habitat re-creation.

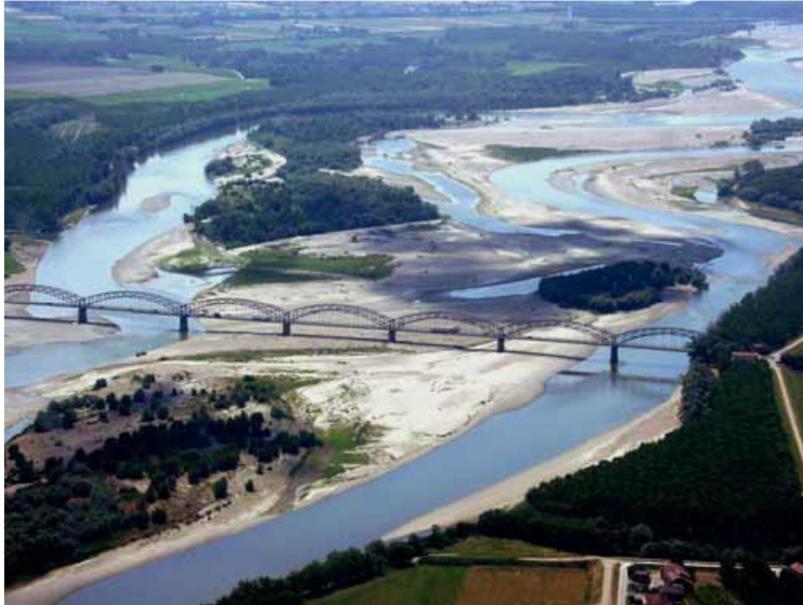
Figure 3.2 Aerial view of the River Po in its middle course, near the 'Mezzana Bigli' bridge. Photo: Autorità di Bacino del Po, extracted from Gumiero et al. 2009.

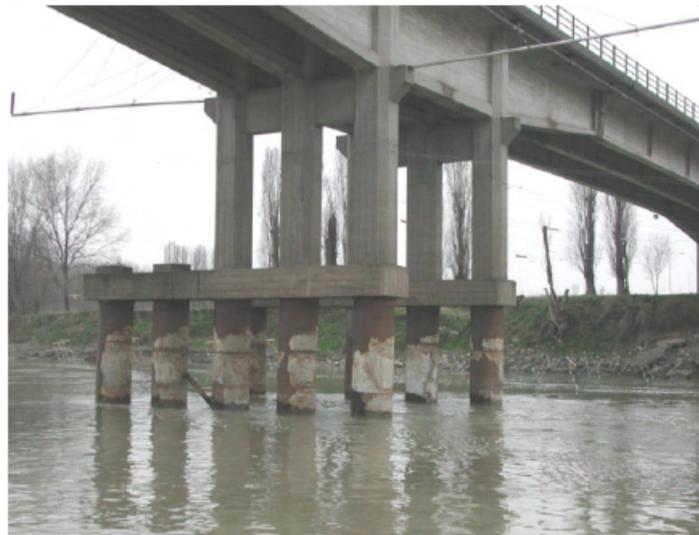
Figure 3.11 Bridge piles on the Po River (Boretto): evidence of channel incision. Extracted from Bertolo et al. 2009.

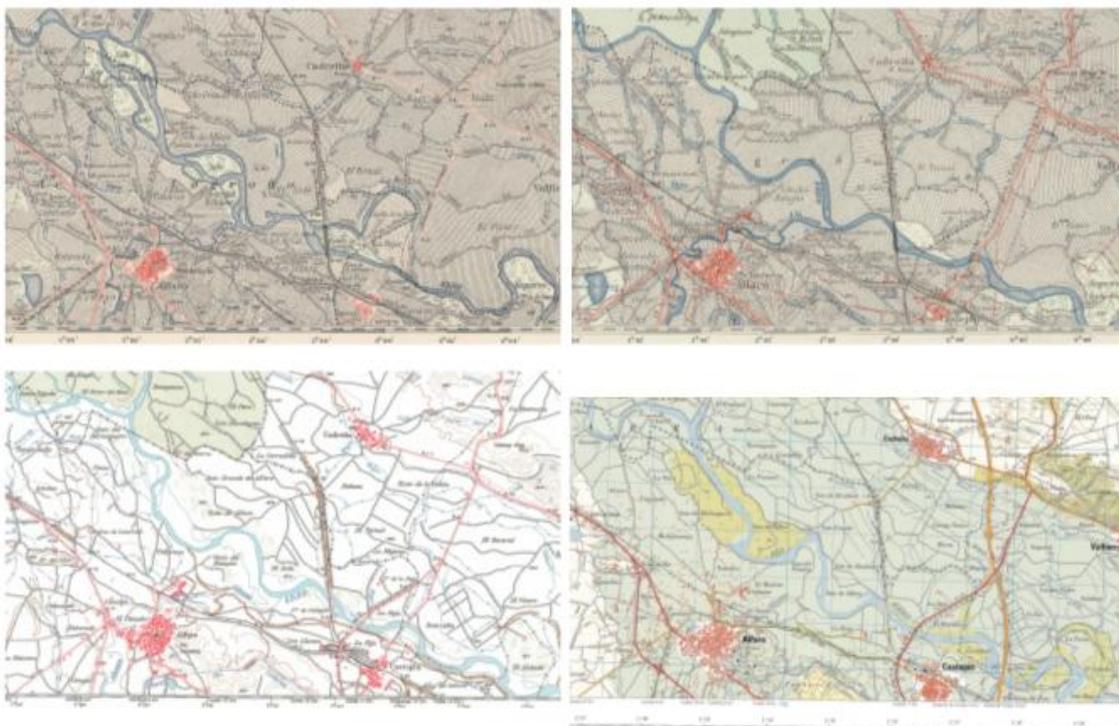
Figure 4.3. Maps of the case study reach in 1920, 1950, 1978 and 2004. (Maps: © Instituto Geográfico Nacional de España)

There are no reliable large continuous flow data series going back as far as 100 years. The flow regime of the earliest 20 years period with available data (1948-1967) can be classified into the 'perennial flashy' type (Table 4.1, Figure 4.2). Since this type describes the flow regime prior to major regulation, it can be assumed as historical or near reference hydrological condition. According to historical maps and aerial photographs (Figure 4.3 and 4.4), the case study reach could be classified as Type 6 'unconfined multiple threat braided'.

In natural conditions, floods have been the main driving force for channel morphology changes in the middle river Ebro. There have been continuous changes in the channel morphology throughout history: sudden meander cut-offs produced during flood episode, and progressive concave bank erosion, producing migration of each meander (Ollero, 1992) (Figure 4.3 and 4.4).

According to the extended river typology (D 2.1) and based on historical data (maps and aerial photographs, see Figure 4.3 and 4.4), this reach was originally (early 20th century) Type 6 'unconfined multiple threat braided', and passed through a transitional stage of Type 5 'unconfined transitional wandering' in the mid-20th century. It currently can be classified as Type 4 'unconfined single threat meandering' (Table 4.3).

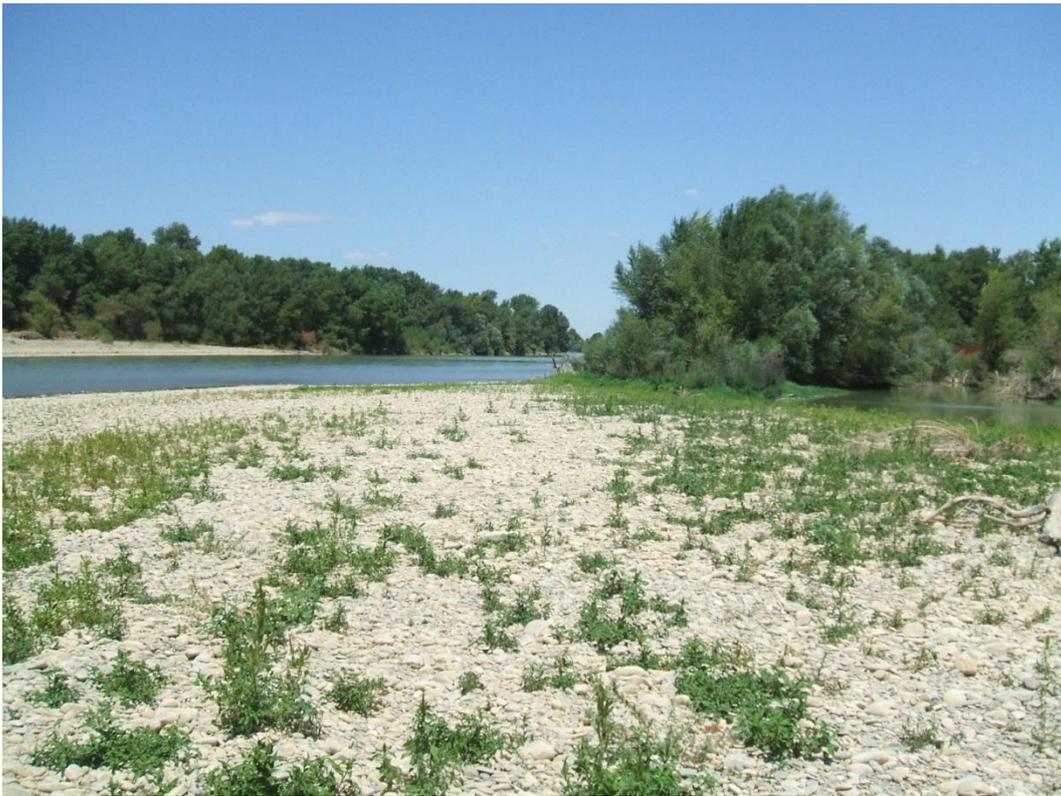
Figure 4.5. View of a section of geomorphic units at the case study reach (Sotos de Alfaro, Alfaro, La Rioja). (Photo: Alonso, C. 2008)

Current significant pressures at the sub-basin of the case study segment (Figure 4.5 and 4.6), consigned in the Ebro River Basin Management Plan 2010-2015 (Ebro RBMP 2010-15 [CHEbro 2013a]), are the following:

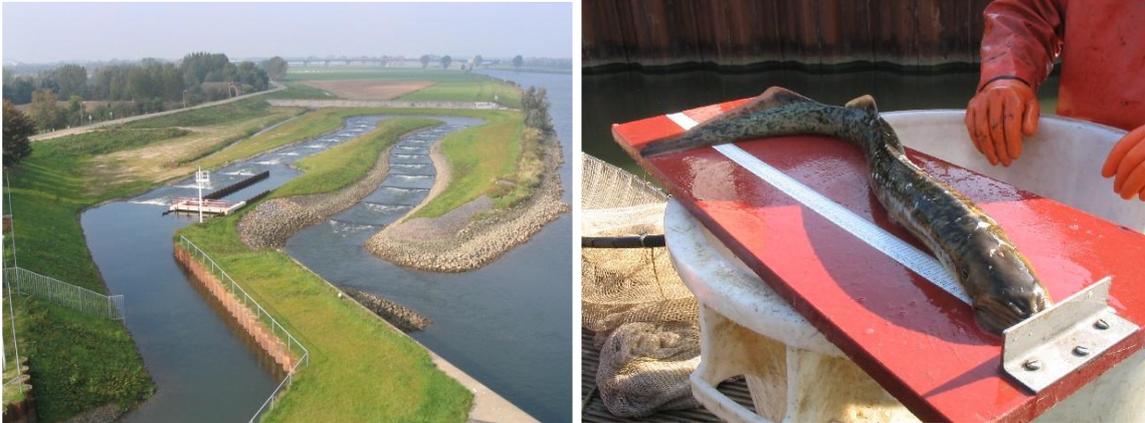
Figure 5.10 The fish pass near Hagestein in the Neder-Rijn. Monitoring showed that among 38 fish species numerous diadromous lampreys migrated through this fish pass. (Photos: Tom Buijse)

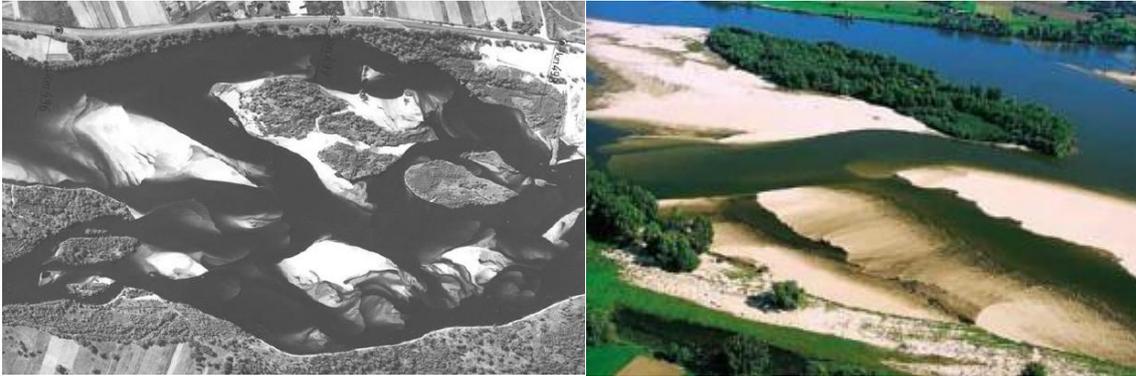
Figure 6.3. Typical morphology of braided river (left side - Halcrow 2013)

The Middle Vistula River has the nature of a braided river, where permanent islands and temporarily occurring sandy fluvial deposits divide the riverbed into river branches (Figure 6.3). The main current of a braided river is sinuous and frequently changes its location (Figure 6.4). The bed morphology of a braided river is determined by the absence of stable flow throughout a hydrological year as well as by the intense bed load transport. According to Schumm (1971), the main factor determining the development of a braided river is the share of the bed load higher than 11% in the total volume of the sediment, i.e. the suspended load and the bed load. According to the research conducted by Skibinski (1994), the Vistula River in Warsaw carries on average approximately 500,000 m³ of bed load a year, which constitutes approximately 35% of the total load volume carried by the Vistula River in this cross-section.

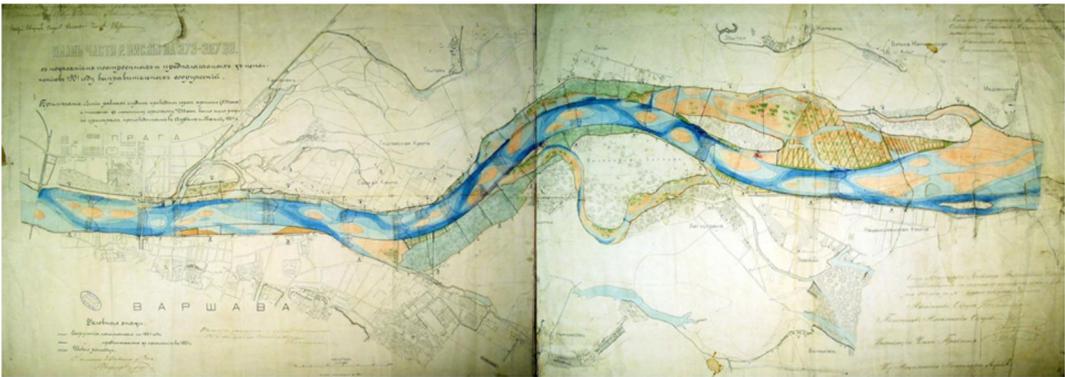
Figure 6.8. The project of the Vistula River training works made by Kostanecki in 1873, executed by Lindley in 1884 – 1889 as a part of the water supply infrastructure project in Warsaw (Damiecki i in. 2008).

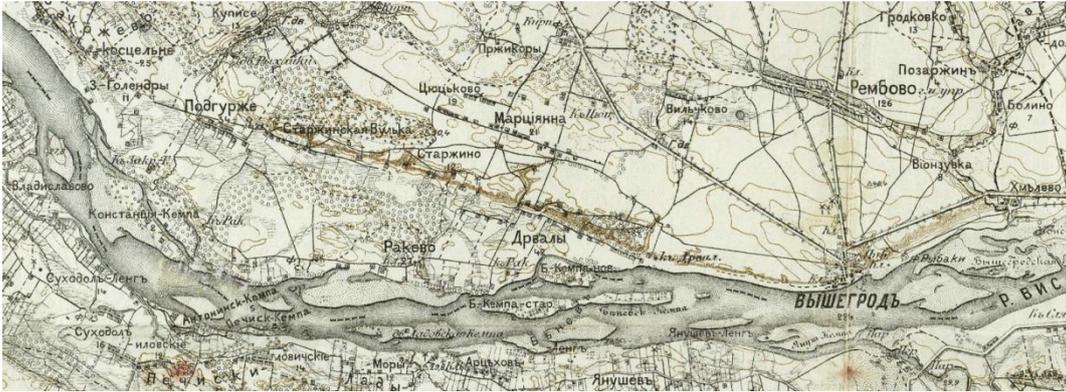
Figure 6.12. The Vistula River section between Wyszogrod and Zakrzewo in 1880 on "The new topographic map of west Russia in scale 1:84 000" - sheet XXII -7

Interesting observations relate to changes in the position of islands within the Vistula riverbed. Two island types can be distinguished: permanent islands with high vegetation as well as sandy fluvial deposits. These structures differ significantly in their change of shapes and rate of movement in the riverbed. Research carried out by other authors (Babinski 1992, Dobrowolski & Glowacka 2002) indicate that sandy channel bars move at a rate dependent on hydrological conditions. In the case of increasing flow by approximately 30% (about 1 m upstream from the mean water level), more than twofold increase in the movement rate of the channel bars head from about 0.7-1.0 m·day⁻¹ to more than 2.0 m·day⁻¹, occurs (Babinski 1992). Channel bars are more stable structures. The majority of stable islands analyzed in details have been present at least for 200 years. This can be seen when comparing the old cartographic materials such as the map from 1888 (Figure 6.12).

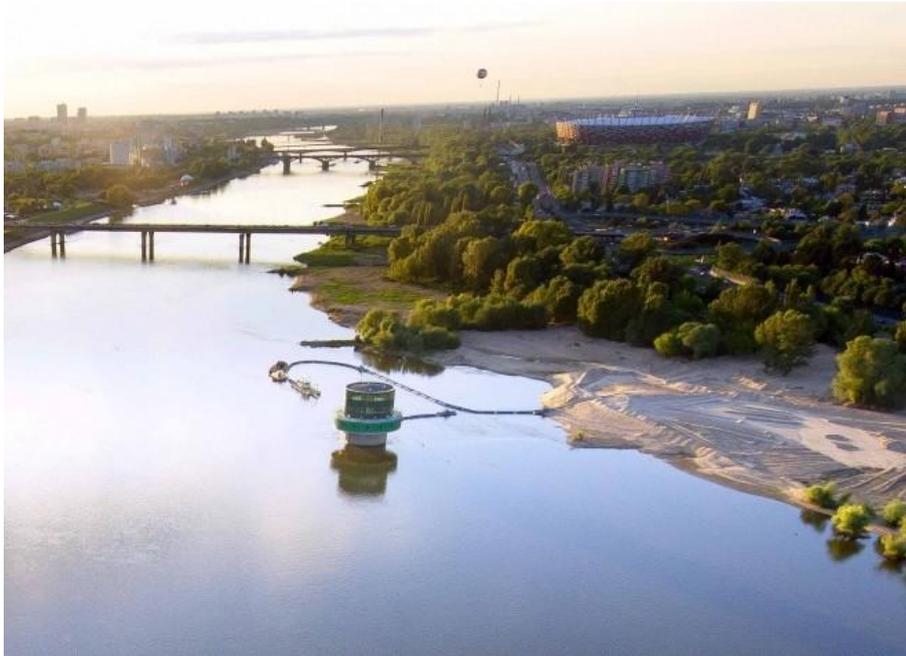
Figure 6.14. View of the „Fat Kate” water intake (www.mpwik.pl/o-firmie/galeria, access: 03.07.2015)

Water for municipal purposes is drawn from the Vistula River by infiltration intakes provided with wells and drains located in alluvial layer under the bottom of the river, whose total length equals almost 10 km. Out of the seven infiltration intakes of the Vistula waters, two on-shore intakes are located on the right bank of the river and four – on the left bank. The main seventh intake – called "Fat Kate" – is located in the river's current (Figure 6.14). Each of the on-shore intakes is equipped with 6-8 drains. The "Fat Kate" is the biggest infiltration well in Europe, water is drawn here via 15 drains, 100-180 m long each, spaced radially under bottom of the Vistula River.

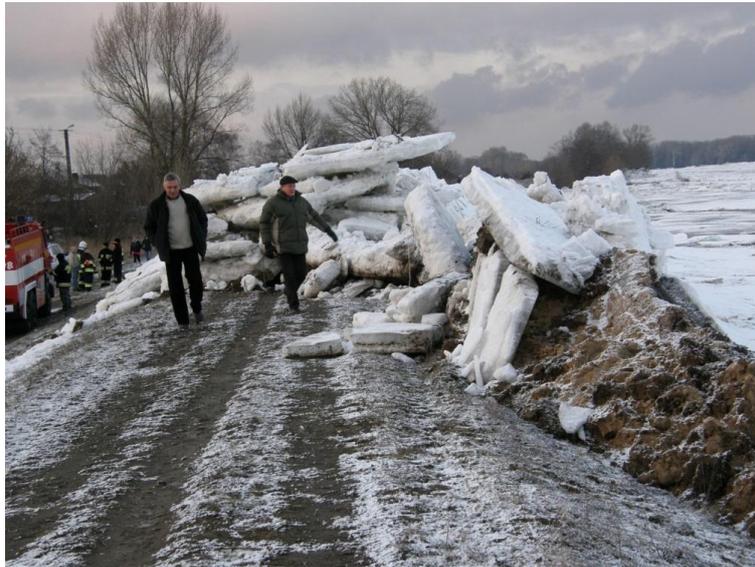
Figure 6.16. Ice-jam on the Vistula near Plock (04.03.2010) – damaged embankment at km 597

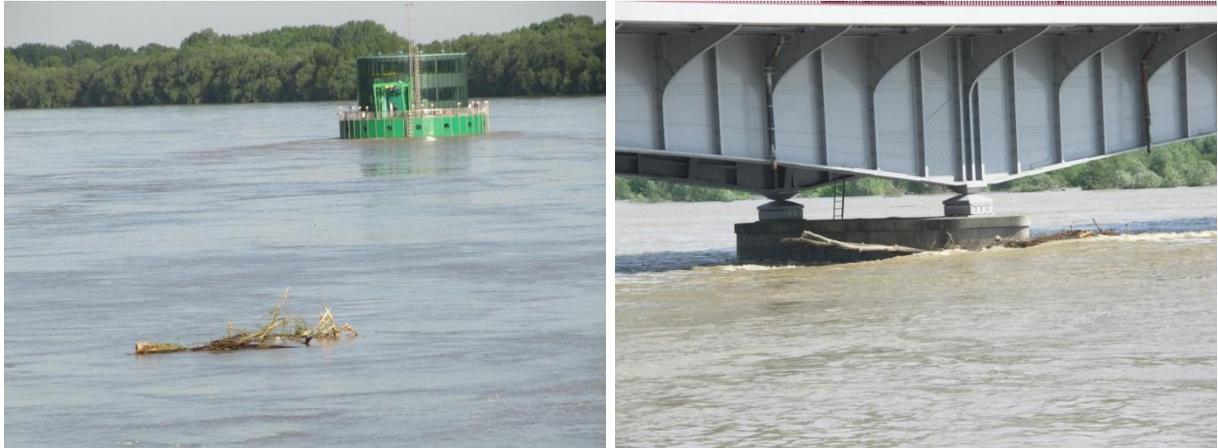
Figure 6.18. Views of the Vistula River on 22.05.2010 during the peak water stage 780 cm (21 cm below the stage of 100-year flood): left picture shows view of the „Fat Kate” water intake (km 511), right picture shows the Slasko-Dabrowski Bridge (km 515).

Very large potential danger of flooding occurs mainly in Warsaw as a result of the intensive development of the Vistula River valley (KZGW 2015). The area within the 100-year flood flow is estimated to about 125 km² (Figure 6.17). During the last high flood in May 2010 (Figure 6.18) in several places of Warsaw (marked on the map – Figure 6.17) were dangerous seepage through or under the embankment, but the flood damages did not happen (Kuźniar 2011). However the flood damages were noticed downstream, in the region of Plock. The left-sided part of the Vistula River valley has

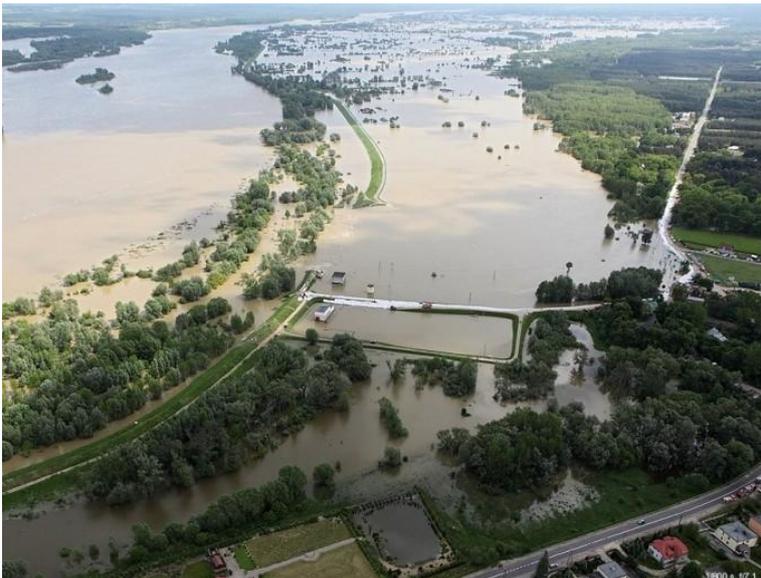
Figure 6.19. Flood in the Vistula valley near Plock in May 2010.

been flooded on the surface of approx. 56 km² after a breakdown of embankment at km 609 (Figure 6.19).

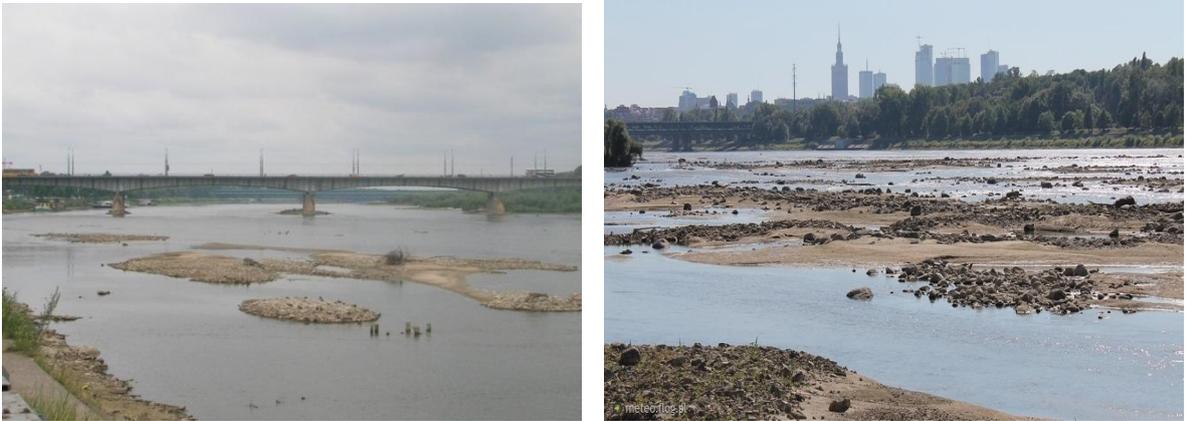
Figure 6.22. View of the Vistula riverbed in Warsaw at low water level - partially uncovered the natural thresholds (culminations of alluvia basement) covered by residual gravel and boulders: a) at km 514, b) at km 517.

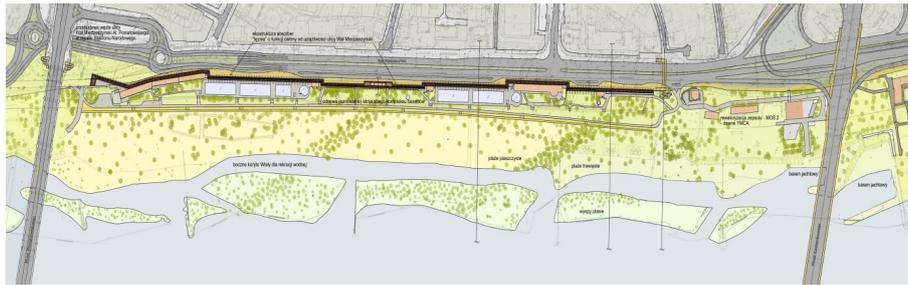
Figure 6.32. The Vistula River Park – conception of reconstruction of goyne’s system located on right bank of the river between two bridges: Lazienkowski and Poniatowski (Damiecki et al. 2008)

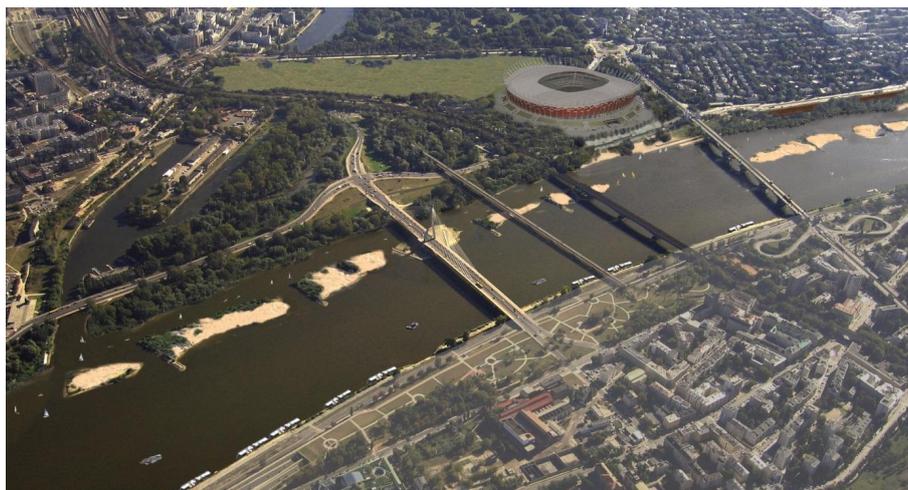
Figure 6.33. Visualisation of regulation works reconstruction project and dam up the river – view on the section between National Stadium and Praski Harbour (Damiecki et al. 2008)

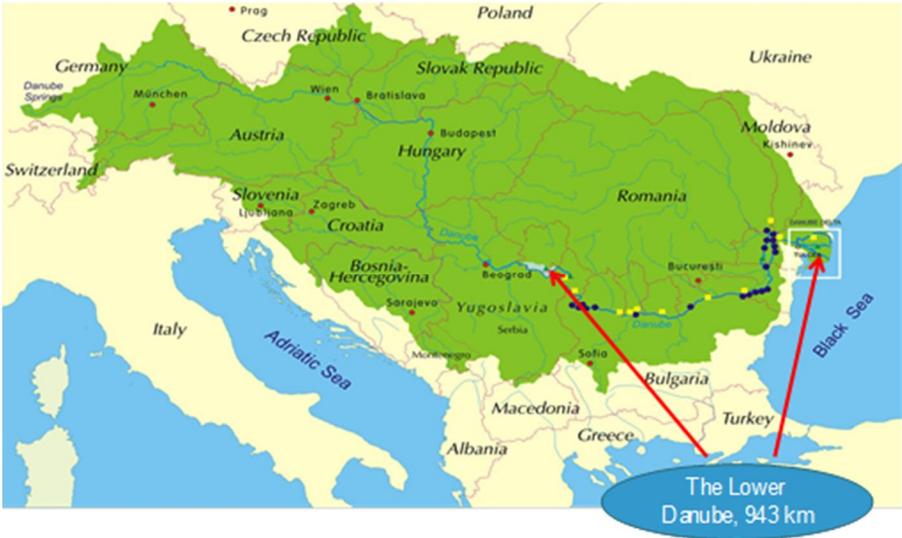
The Danube River is the world's most international river basin as it includes the territories of 19 countries and is home to 83 million people. The main characteristics of the Danube are summarized in Table 7.1. The length of the river is almost 2,900 km from source to mouth. The Lower Danube is represented by the last 942 km of the river before flowing in the Black Sea (Figure 7.1).

Figure 7.1. The Danube River basin and its Lower Danube section
